**Shipping Guidance Notice – 027**

**Failure of the High Velocity Vent Valve**

## MARINE SAFETY ALERT

### High Velocity Vent Valves, Vacuum Valves, P/V Valves

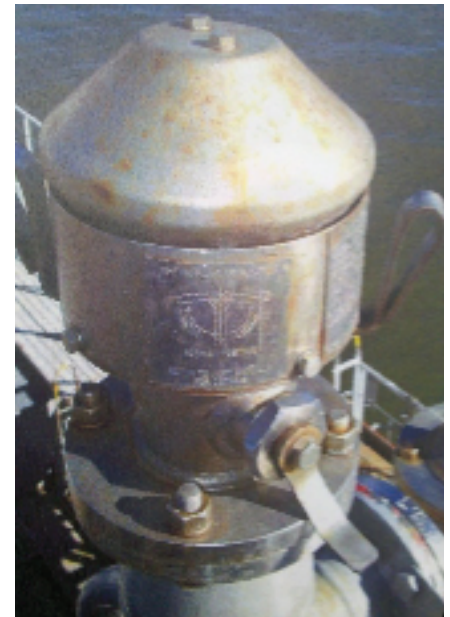
The investigation is nearly complete and investigators have identified several causal factors, one being the failure of the high velocity vent valve which did not open and prevent over pressurization of the tank while it was being filled.

After this specific casualty, the high velocity vent valve of the tank being filled was found stuck closed and inoperable using the manual test lever. A valve for another tank was also found stuck. Scientific testing of the substance between the stuck valve disc and the seating surfaces indicated the presence of oxidized vegetable oil or fat likely from previous cargoes. It appears doubtful that crewmembers exercised the valves prior to their cargo operations as per their operating procedure.

As a result of this casualty and others involving similar circumstances, the Coast Guard **strongly recommends** to vessel Owner / Operators, Crewmembers, Classification Society Inspectors, Vetting, and other inspection personal ensure that tank high velocity vent valves and vacuum valves, or combination pressure / vacuum valves are maintained in operating conditions at all times and are routinely checked as procedures require.
